River Embankment and Bank Failure in Bangladesh: A Study on Geotechnical Characteristics and Stability Analysis

Md. Bellal Hossain, Toshinori Sakai, Md. Zakaria Hossain
 Graduate school of Bioresources, Mie University, Japan

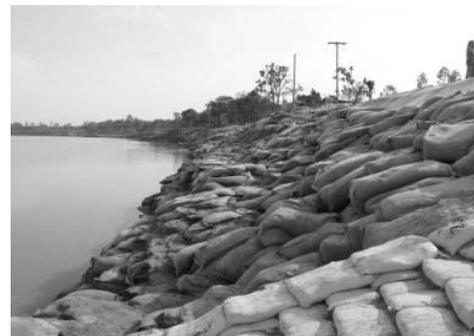
Fig. 5 Sandbags on embankment slope

So, the embankment constructed with this material needs lot of care to control water content and the strength level. As embankment material; it has got a very low strength and thus, very vulnerable to slope failure and erosion process. Hence, the slope surface needs to be protected from erosion caused by the rainfall, run off and the strong wave during high flow of river. However, the slope of the embankment of Jamuna river is found not well protected. In some places of the embankment, sandbags have been used but not worked well due to inefficient placement and lack of maintenance (Fig.5).

Moreover, the sandbags are placed only in the emergency situation of flood. But, it is equally important to protect the slope surface during other times to protect from wash-off the fine particles by rainfall as well as run off.
